Arkansas State Claims Commission

State of Arkansas, Respondent AR Highway Dept.

COMPLAINT

**COMPLAINT**

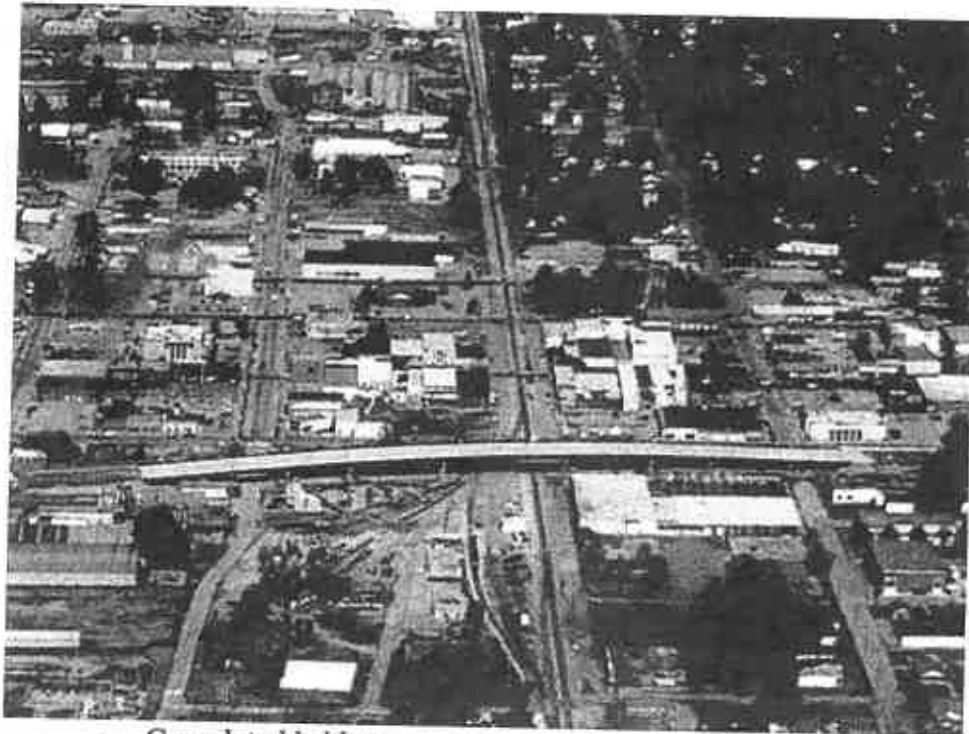
- Completed bridge.

The bridge is oriented from west to east with two abutments and eight intermediate bents (Abutment #1 to Abutment #10 going west to east). The bridge is founded on round steel pipe piling (24-inch diameter x .500" thick) which are filled with concrete after driving. The balance of the substructure consists of cast-in-place, reinforced concrete footings, columns, and caps.

Each of the eight intermediate bents has five foundation footings and columns topped by the bent cap. Nine piles are in each of the footings. The abutments each have nine piles which are topped by a reinforced concrete cap.

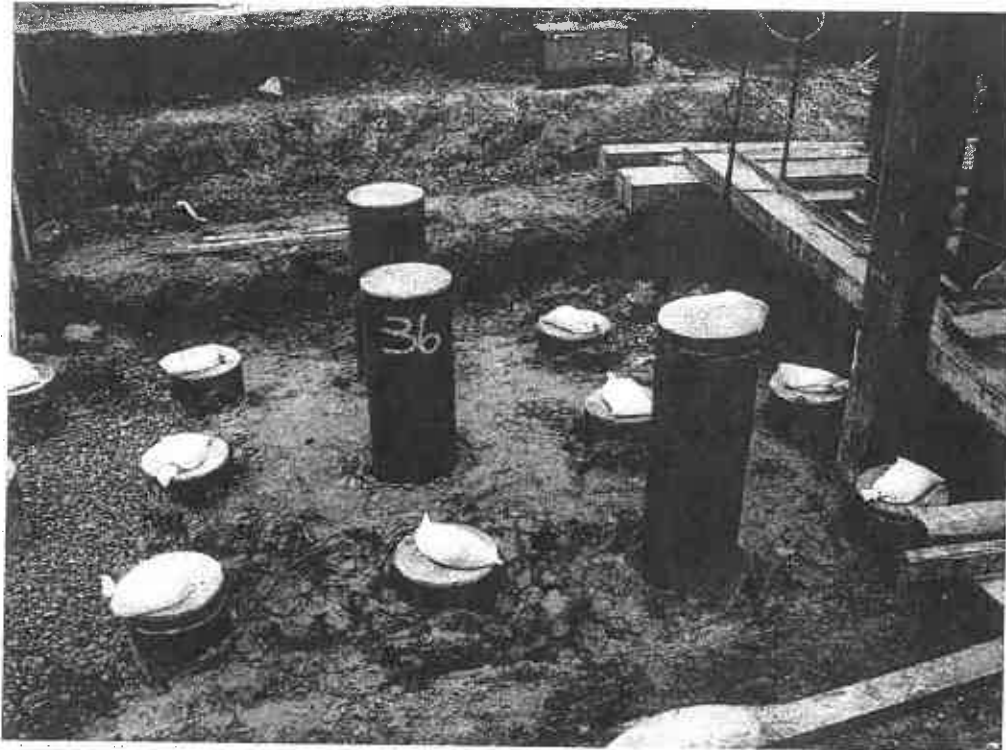
-Concrete-filled steel pipe piling prior to footing concrete placement.

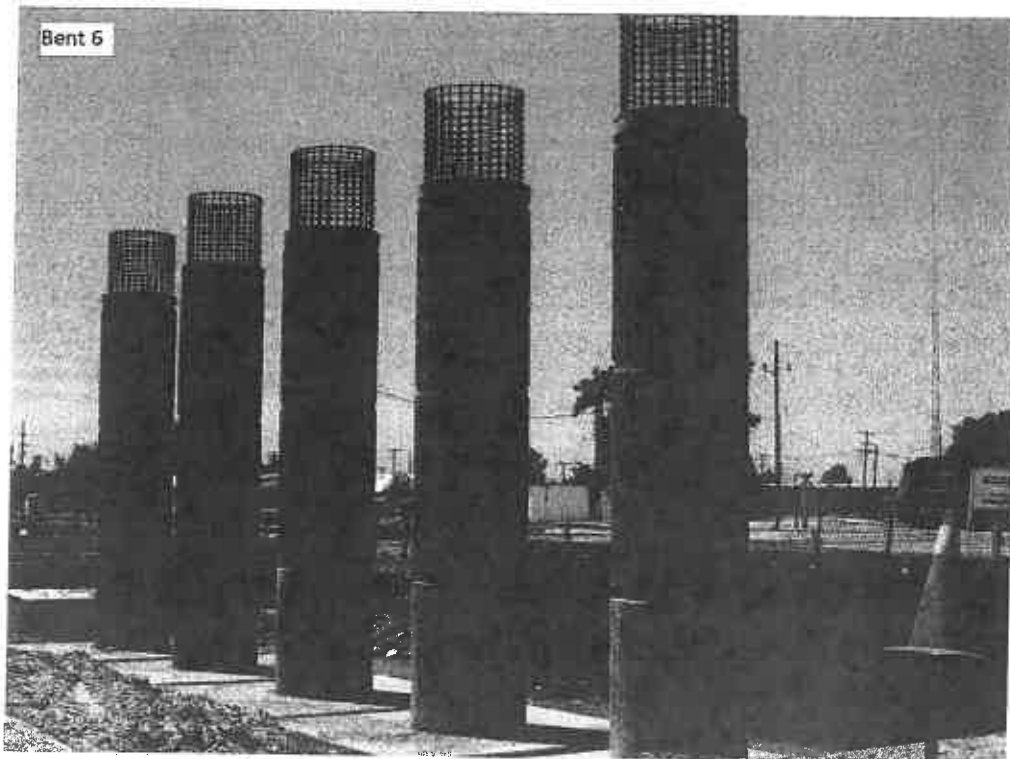
-Reinforced concrete footings and columns.

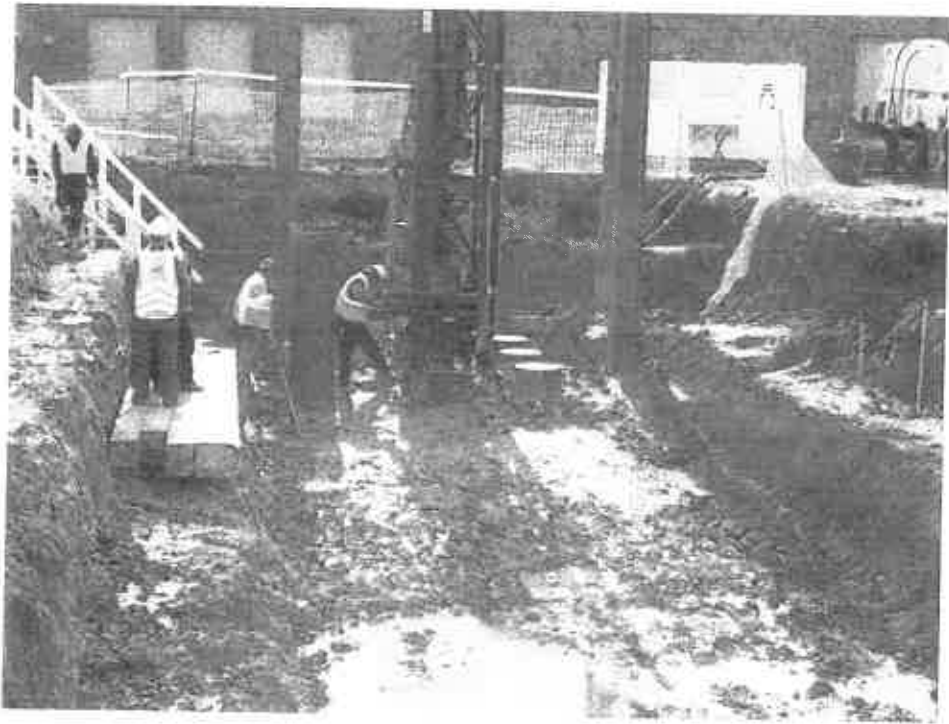
AHTD was to pre-bore each pile hole from the bottom of the footing elevation to 10 feet deep, insert the pile, drive the pile to the template, remove the template, and complete driving the pile to the required minimum tip elevation.

*Images of the Delmag Pile Hammer driving pile.*

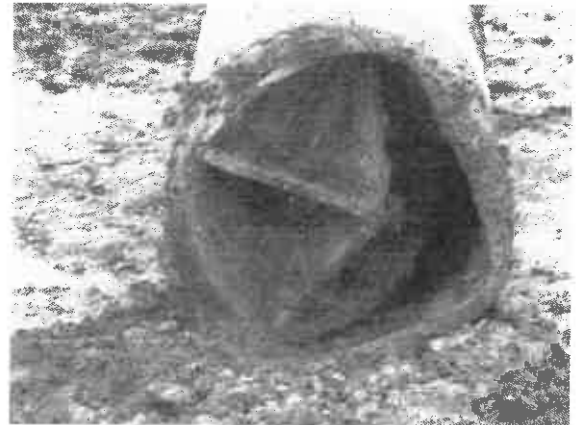
Damaged Piling

Early during the pile driving, a number of the piling were damaged to the extent that AHTD rejected the use of those piles in the foundation. This resulted in Rosiek having to extract and replace them.<sup>6</sup> A pile was first damaged on January 17, 2012. On January 23, 2012, AHTD directed Rosiek to stop driving production pile until the cause of the damage to the pile could be determined.

Two of the damaged piles were extracted on January 24, 2012. After AHTD, Rosiek, and Skyline Steel (the steel pile supplier) examined the damaged pile, it was evident that the cause of the failure was due to an inadequately designed vaned tip which could not withstand the maximum driving resistance required to reach the minimum tip elevation. The maximum driving resistance is the amount of resistance which must be overcome in order to drive a pile to the minimum tip elevation and achieve the minimum bearing resistance required.
